August 2016–May 2017 • Volume 9, Issue 1 (Published since 2009), June 16, 2017

### Second Special Edition on Electrostatic Discharge (ESD)

## ESD, the Silent Killer

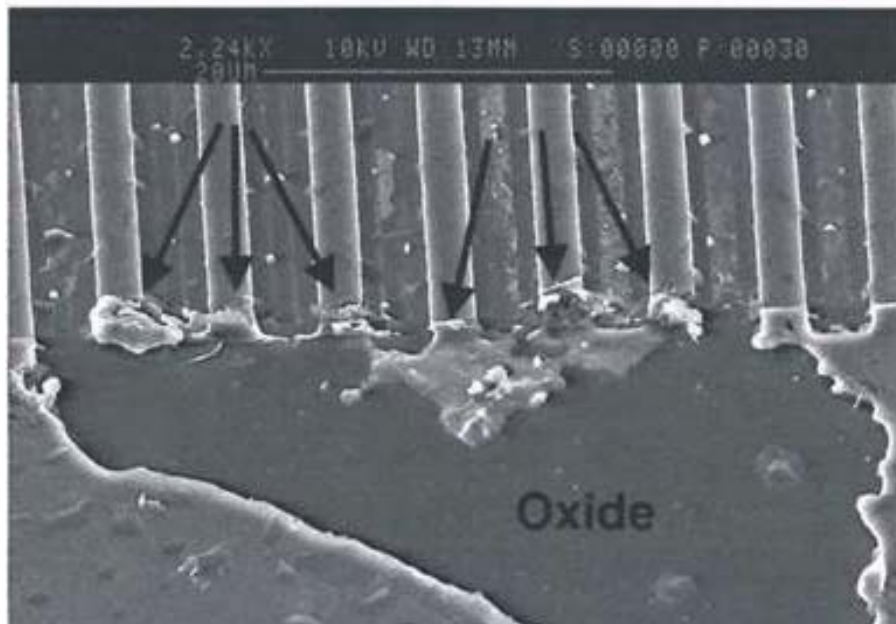
**Fig. 1. Detailed view of a damaged site on a metal oxide semiconductor field-effect transistor (MOSFET) probably caused by ESD.**

Figure 1 is an example of damage that was probably caused by ESD.

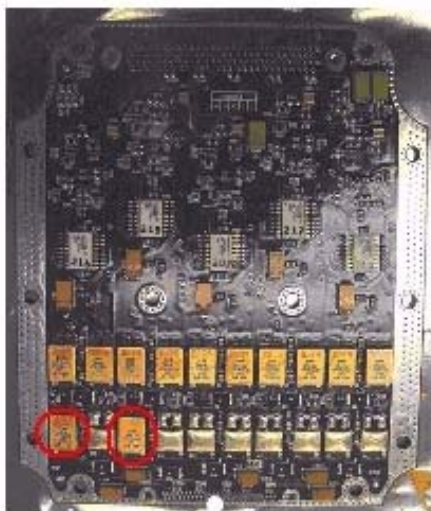
Figure 2 shows the PCB assembly with two noted non-functional parts circled in red. Although not conclusive, the corner location of damaged parts on the board was thought to be important to the forensics analysis. One theory implied that handling of the board (by the perimeter) allowed for the ESD event to contact these parts directly. During transport, the board is handled only inside an ESD-approved materials bag. There were questions as to the integrity of these transport bags. Due to bag traceability and reuse issues, there was no definite conclusion on this concern.

Fig. 2. Damaged parts are circled in red.

The conclusion of this ESD failure investigation was that failure was attributed to user error but review of all ESD compliance logs showed that all precautions were taken during operator handling. Due to lack of further evidence, the OCM and the PCB assembly operation were not ruled out as possible culprits, but neither could be confirmed.

Under these circumstances the team was advised of the event and warned of the total cost for repair and the need to double check all future handling procedures. The board was repaired with same lot date code parts, and there were never any repeat operational issues with that PCB assembly nor at the box operational level. The "Silent Killer" only struck once on that program. At least as far as can be determined at this time.

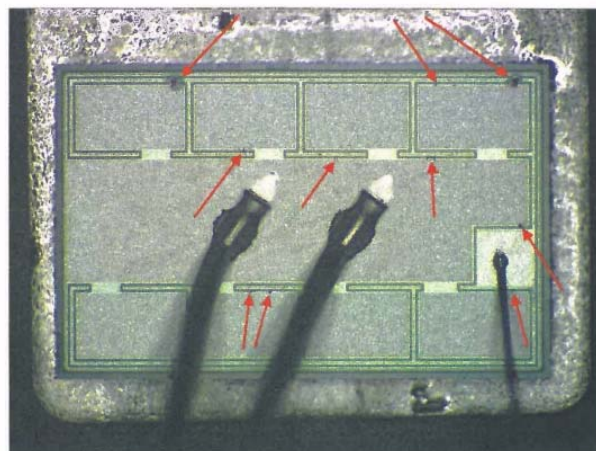
Fig. 3. Optical micrograph of the die in the failed device. The red arrows indicate the damage sites.

Figures 3 thru Figure 7 Show the die and damage areas from various photographic and radiographic perspectives. During upper-level assembly circuit troubleshooting, the potential for design or operational damaging voltages to the MOSFET gates were conclusively ruled out. The circuit was incapable of generating the necessary damaging voltages that would have the effect observed.

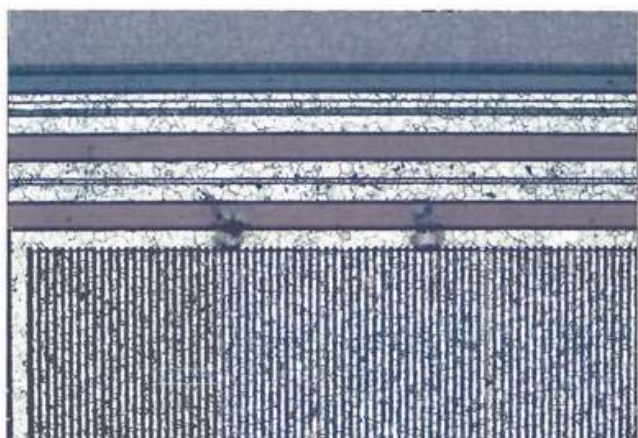
Fig. 4. Detailed view of the damage sites on the die.

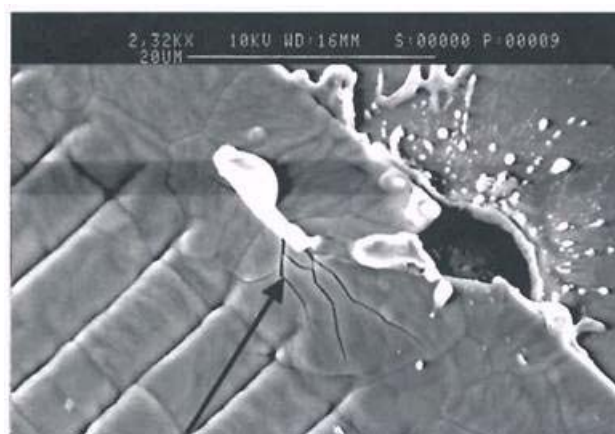
Fig. 5. SEM image of one of the damage sites. The arrow indicates the area where the damage originated

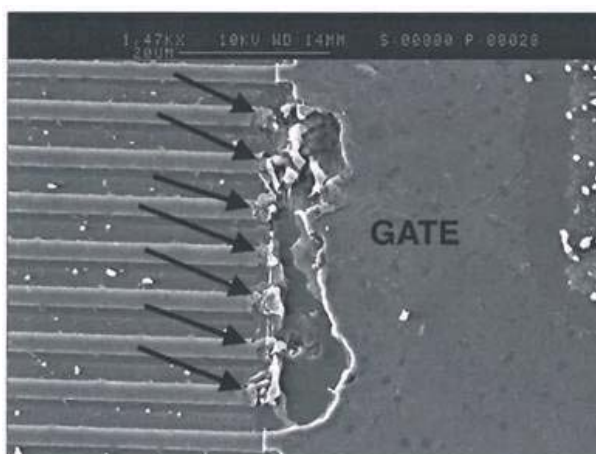
Fig. 6. SEM image of the FET after delayering. The arrows indicate the damage at the ends of the gate runners.

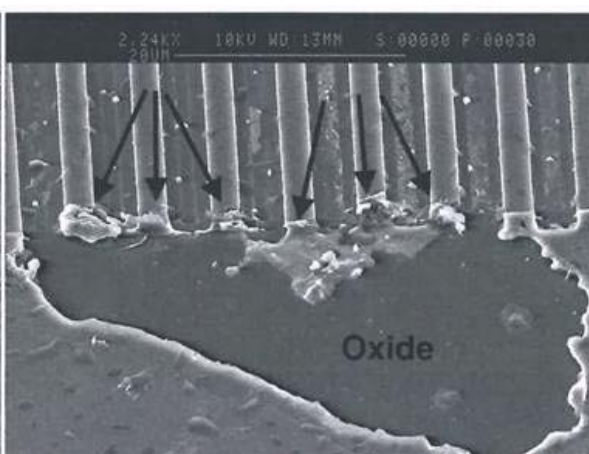
Fig. 7. SEM image of another damaged area on the die. Note that the gate polysilicon fused during the failure, which is why the oxide is visible.

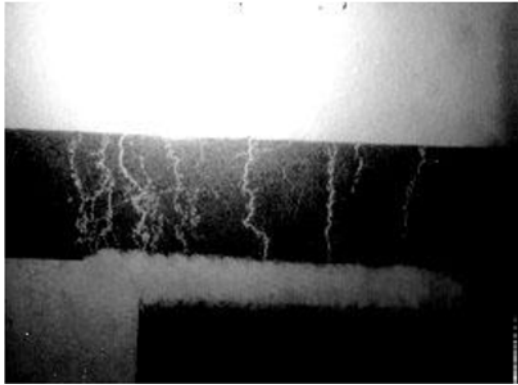
Fig. 8. Vicinal view of ESD induced damage to a thin-film resistor network chip during ground testing [1].

According to the NASA Goddard Space Flight Center, testing has shown that imposed ESD damage produces four basic effects: Little or no damage, current crowding, internal arcing, and external arcing. They reported it was rare to see all of these effects in the same test network. The following images show ESD damage to resistive film layers (see Figures 8–11) [1].

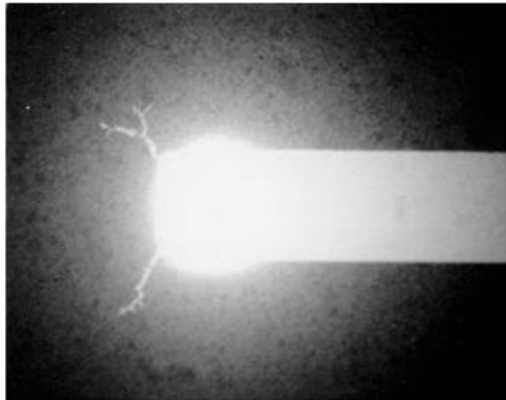
Fig. 9. Vicinal illumination view of corner crowding induced damage [1].

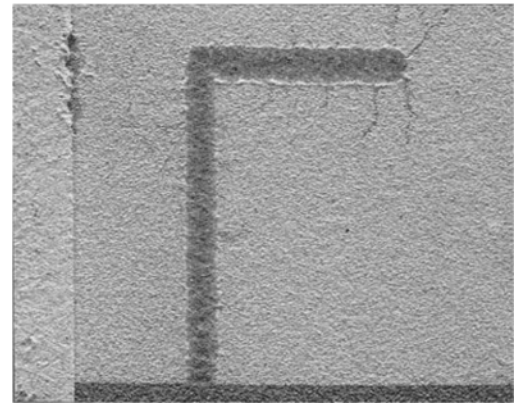
Fig. 10. SEM view of ESD damage in a tantalum nitride resistor. Note the internal arcing damage to the left of the laser kerf [1].

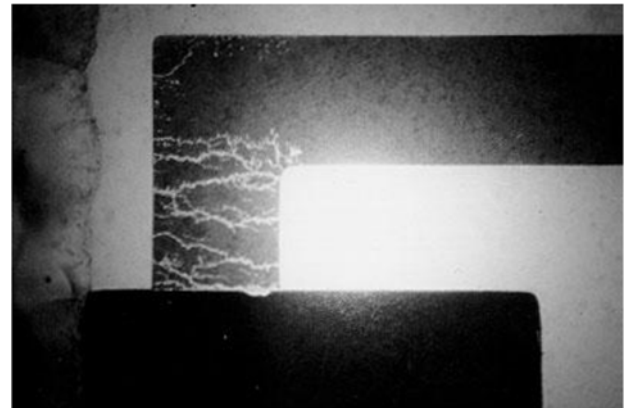
Fig. 11. Vicinal illumination view of transverse cracking typical of relatively high voltage ESD damage [1].
