# Entry System Reconstructed Performance

International Planetary Probe Workshop  
June 17, 2013

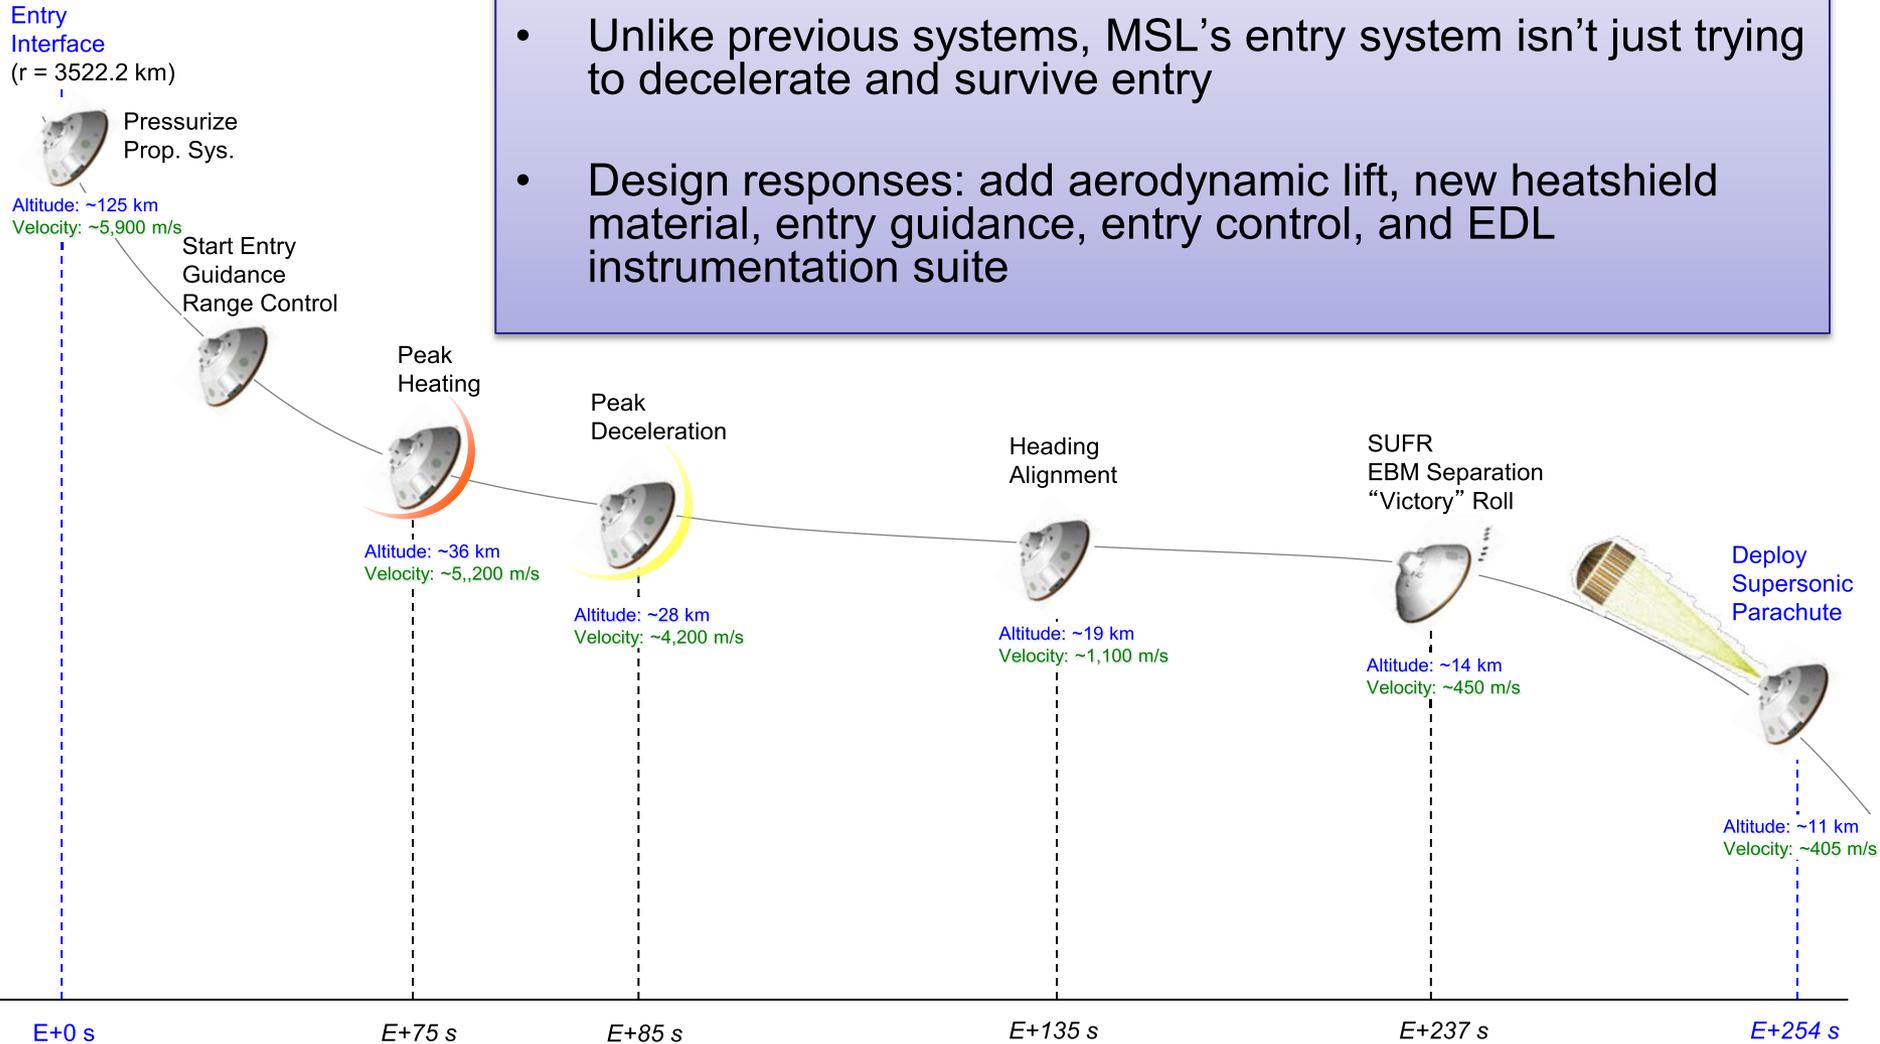
Viking 1/2

Pathfinder

MER A/B

Phoenix

MSL

Viking	MPF	MER	Phoenix	MSL
Diameter (m)	3.505	2.65	2.65	2.65	4.5
Entry Mass (kg)	930	585	840	602	3152
Hypersonic Angle of Attack (°)	-11.2	0	0	0	-16
Ballistic Coefficient (kg/m <sup>2</sup> )	63.7	62.3	89.8	65	136

*Significantly higher mass, ballistic coefficient and angle of attack*

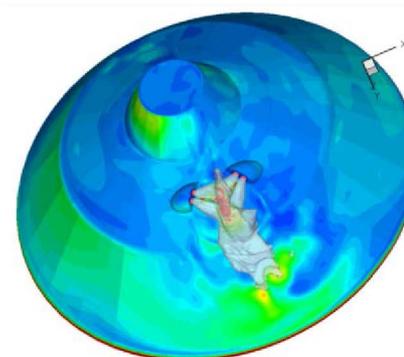
Early MSL RCS configuration with large yaw interactions

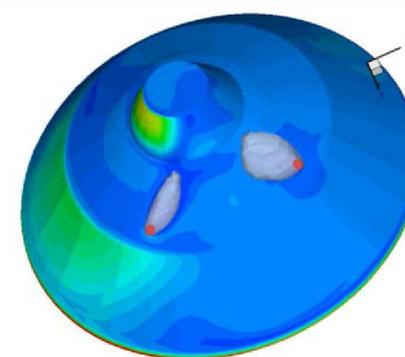
Final MSL flight RCS configuration

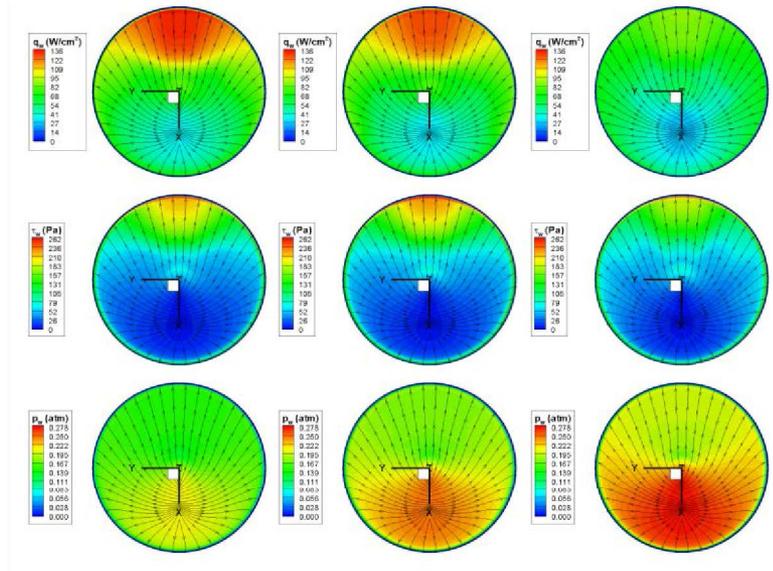
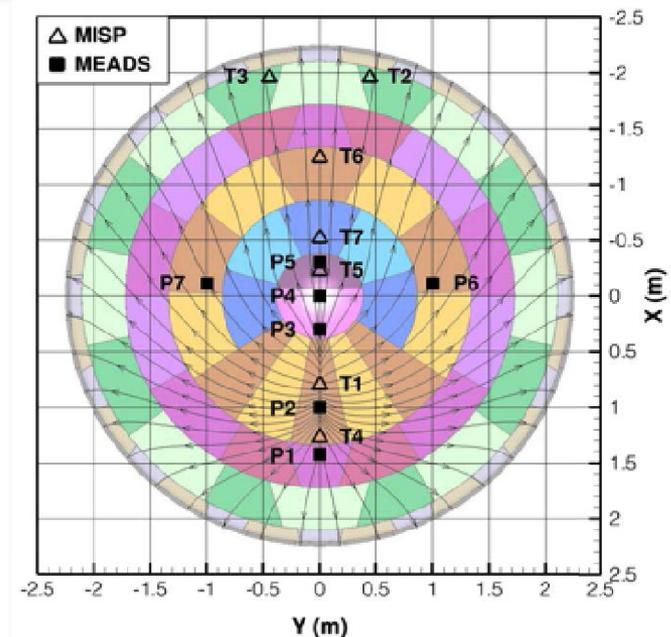
- Reconstructed aerothermal environments and TPS material response with the aid of MEDLI/MISP instrumentation
- Difficult to separate material response from aerothermal environments

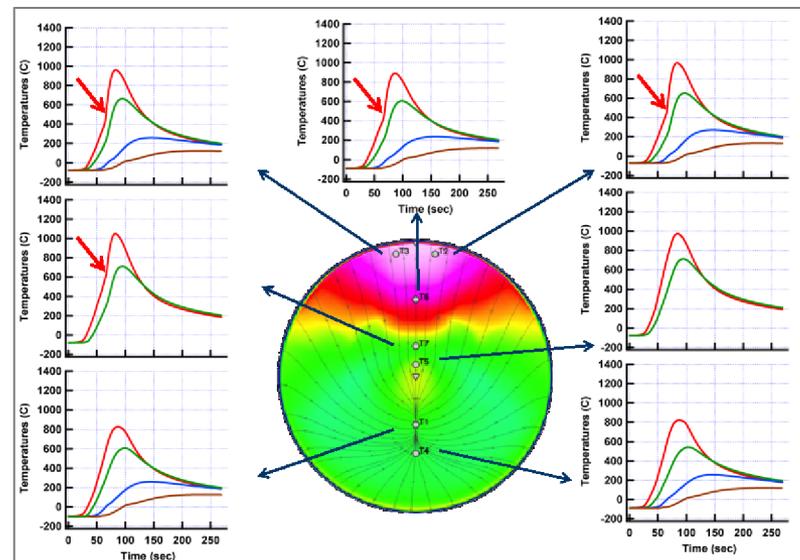
Prediction	Basis for Prediction	Flight Observations
Heatshield boundary layer transition prior to peak heating	CFD, wind tunnel testing	Transition observed at all 4 leeside locations. Transition occurred near expected conditions for 3 of 4 locations.
Highest heatshield heat flux at leeside shoulder	CFD	Leeside shoulder did see highest heat flux, but by smaller ratio than predicted relative to other locations
Heat flux augmentation in stagnation point region possible	Wind tunnel testing	No heating augmentation near stagnation point observed

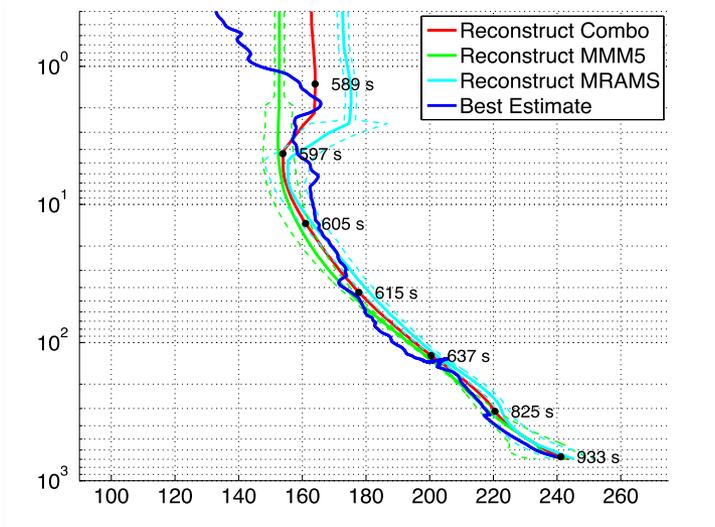
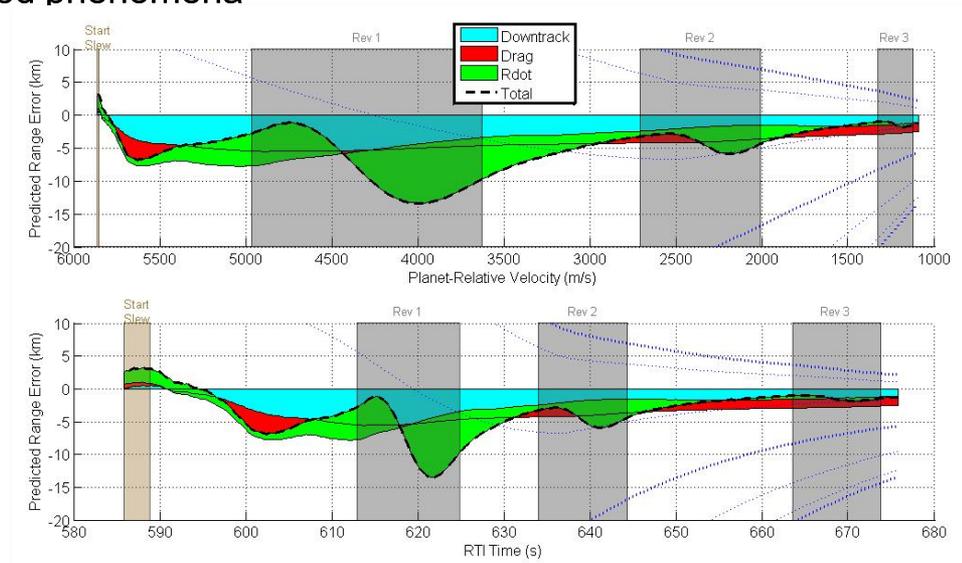
- Spacecraft arrival with minimal delivery error and onboard state knowledge error
- No significant surprises or performance anomalies observed
  - Range control started slightly earlier than predicted, likely a result of higher than expected density in upper atmosphere, but had no impact on overall performance
  - 3 bank reversals during range control, as predicted
  - Completed range control and heading alignment well within expected performance envelope
  - Experienced downrange effects during heading alignment (likely tailwind)
  - Guidance not challenged by any unexpected phenomena

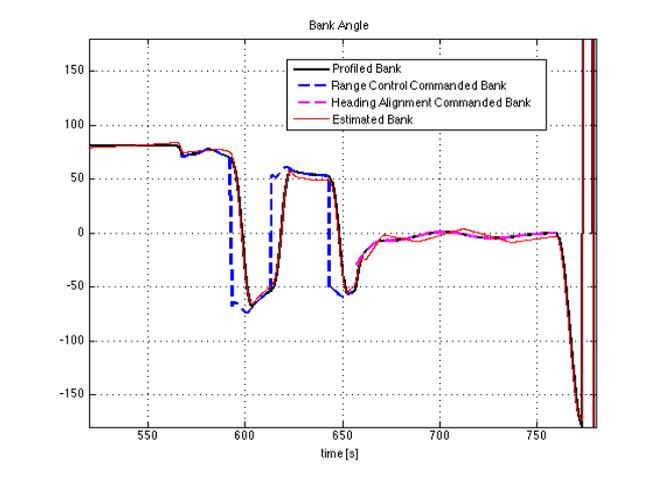
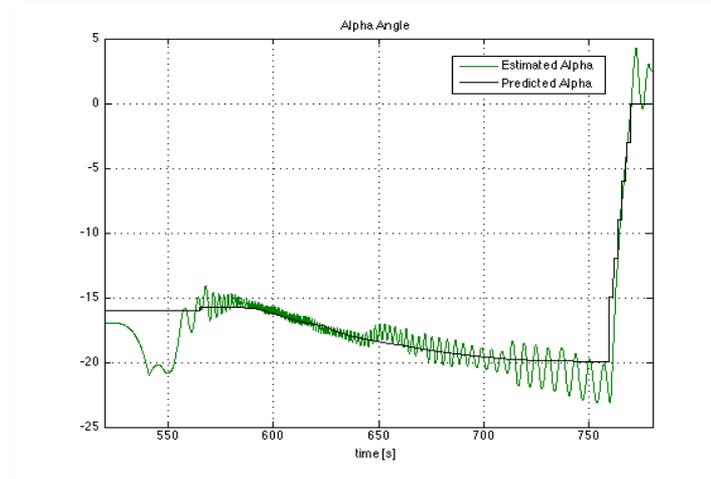
- Entry control performed nominally
  - Control errors remained small and within predictions throughout entry
  - Thruster activity and propellant use were nominal
  - Followed guidance bank angle commands and performed bank reversals as expected

- Not challenged by any significant or unexpected disturbances
  - No evidence of severe roll torques or aerodynamics/RCS jet interactions
  - No large deviations from predicted aerodynamic trim

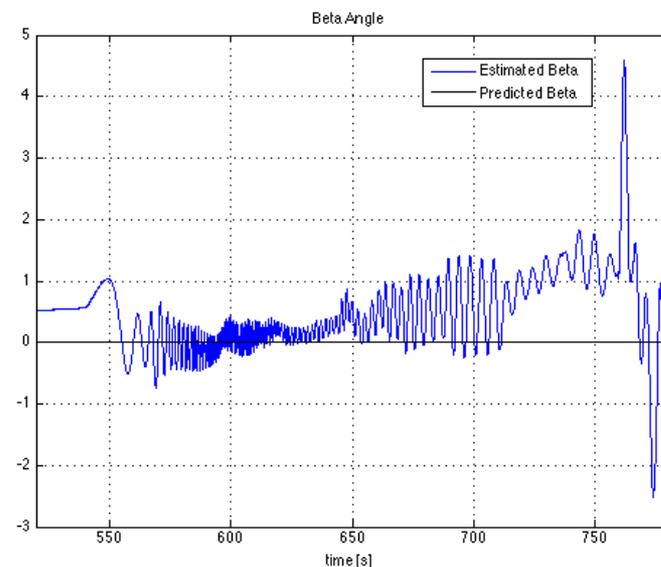
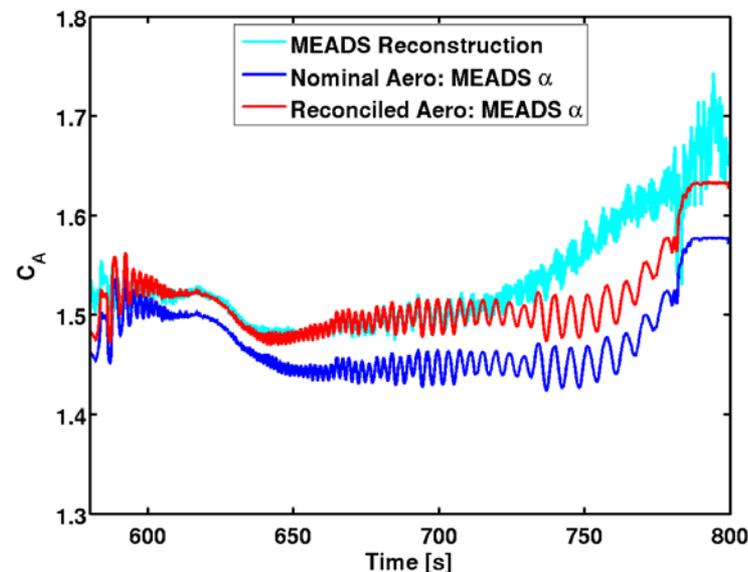
- The team has identified residual issues during reconstruction
- Gradual departure of sideslip from predictions at end of heading alignment
  - No overall system performance impact
  - May be crosswind related
- Total drag during heading alignment was near expected, but aerodynamic contribution appears higher than expected
  - Requires lower drag contribution from atmosphere, potentially tailwind
  - Measurements outside the valid dynamic pressure range for MEADS during this period
- SUFR start to parachute deploy time was longer than expected
  - May also indicate a larger than expected tailwind
