Single-event Effect Report for EPC Series eGaN FETs: EPC2015, EPC2014, EPC2012

JPL Publication 14-7 01/14

NASA Electronic Parts and Packaging (NEPP) Program
Office of Safety and Mission Assurance

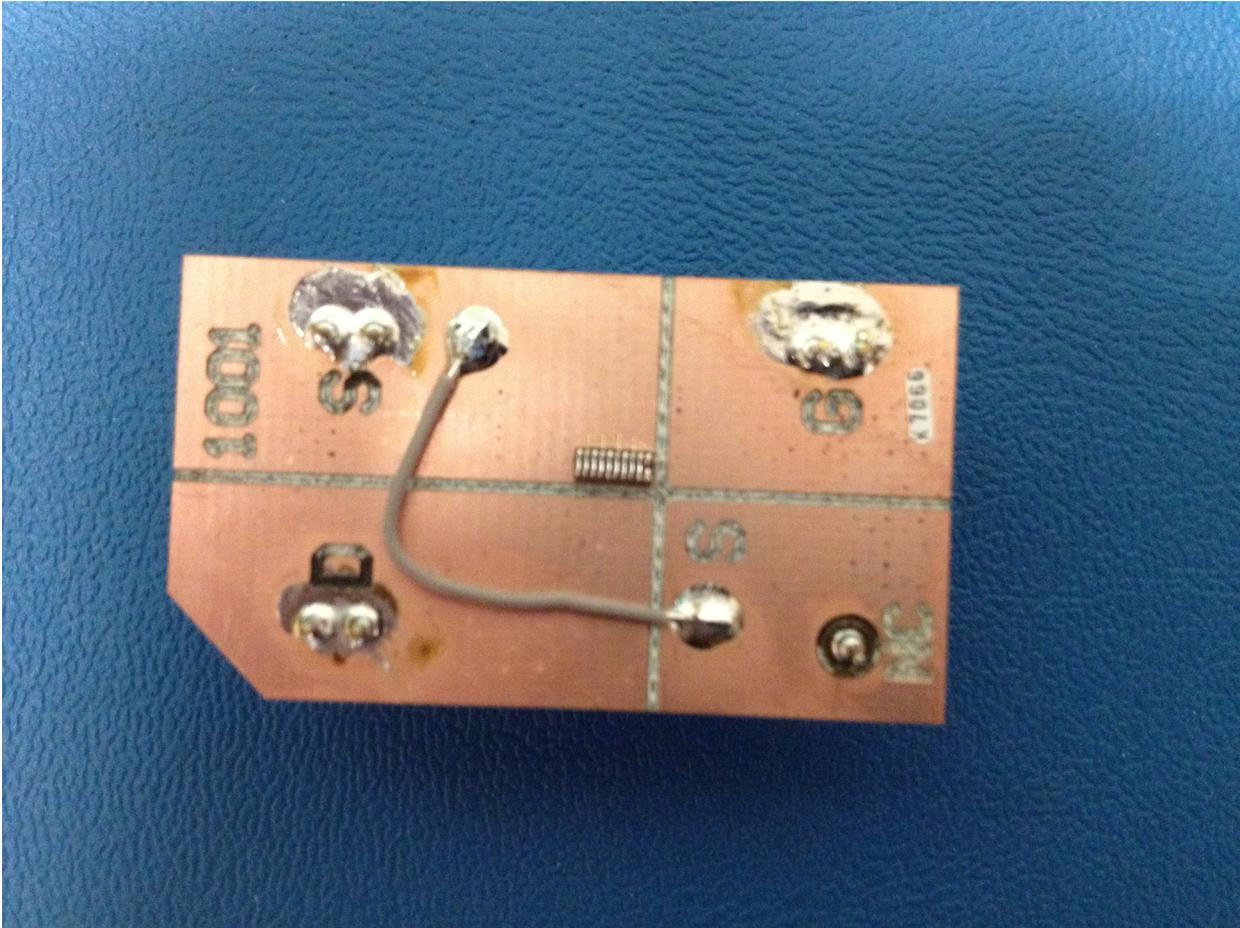
Figure 4.0-1. Dose testing carrier.

General test procedure adhered to the “The Test Guideline for Single Event Gate Rupture (SEGR) of Power MOSFETs” [JPL Publication 08-10 2/08]. Parts were be serialized (if not already done), with controls marked prominently to distinguish them from test samples. Exposures were performed at ambient laboratory temperature. Since the packages from EPC were atypical, the DUTS had to be remounted in a dead-bug configuration for ion testing and testing with the ATE. Devices were verified to be functional after mounting on the test carrier, see Figure 4.0-1. The equipment used in this effort is listed in Table 4.0-1.

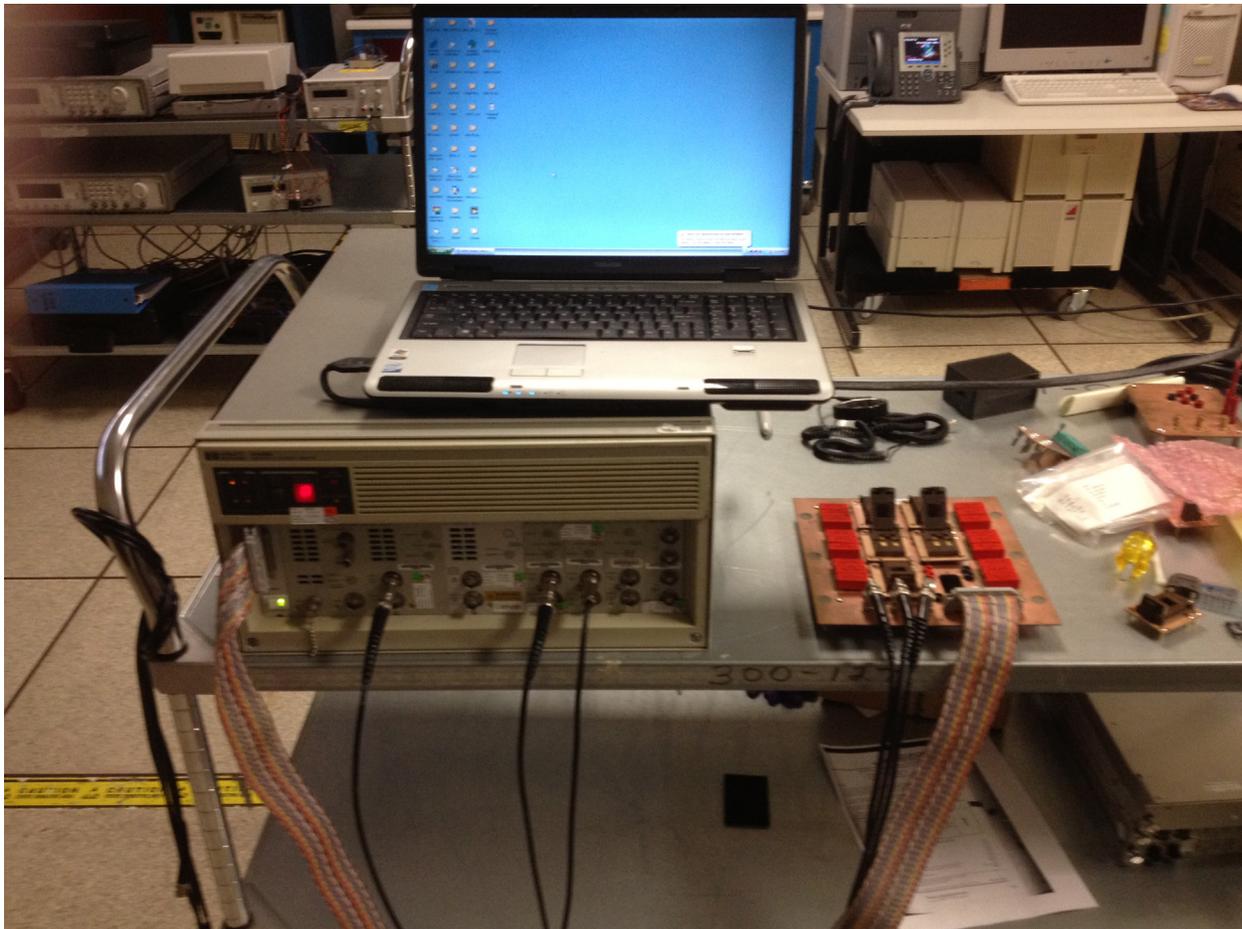
Figure 4.3-1. Setup used for SEE testing. Entire system is transported to heavy ion site.

Failure criteria were classified in accordance with “The Test Guideline for Single Event Gate Rupture (SEGR) of Power MOSFETs” [PL Publication 08-10 2/08]. Figure 4.3-1 shows the setup used in this experiment. An HP4142 forced the voltage and read a current with three independent SMUs. The background current on the board with no DUT was recorded to be ~ 0.5 nA in each device location.

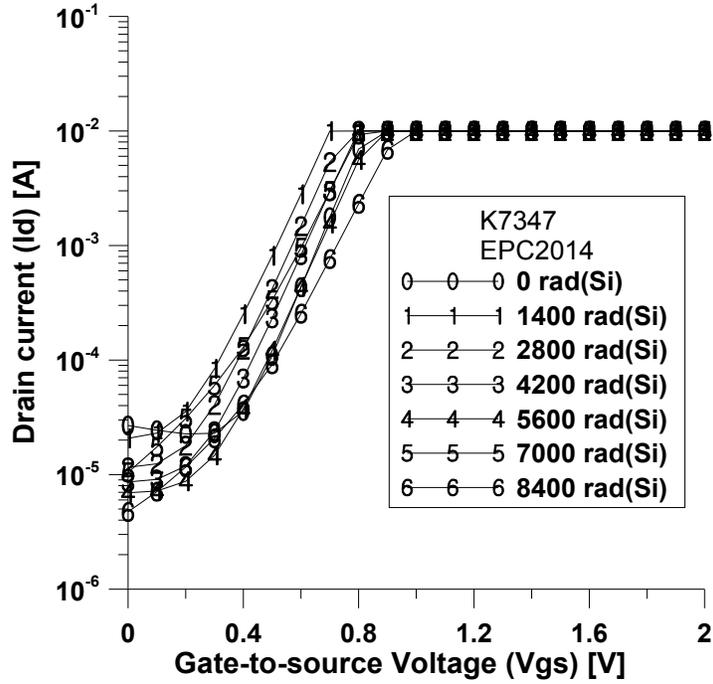
Figure 7.0-1. Effect of heavy ion radiation on the transfer curve of part K7347. Drain voltage was 10 V. No SEE was seen to $V_{ds}=40$ V and $V_{gs}=-5$ V.

- Figure 7.0-1 presents part K7347, EPC2014.
- Figure 7.0-2 presents part K7325, EPC2014.
- Figure 7.0-3 presents part K7328, EPC2014.
- Figure 7.0-4 presents part K7320, EPC2015.
- Figure 7.0-5 presents part K7303, EPC2015.
- Figure 7.0-6 presents part K7305, EPC2015.
- Figures 7.0-7 and 7.0-8 present part K7348, EPC2012.
- Figures 7.0-9 and 7.0-10 present part K7350, EPC2012.
- Figures 7.0-11 and 7.0-12 present part K7352, EPC2012.
- Figures 7.0-13 and 7.0-14 present part K7353, EPC2012.
- Figures 7.0-15 and 7.0-16 present part K7354, EPC2012.
- Figures 7.0-17 and 7.0-18 present part K7359, EPC2012.
- Figures 7.0-19 and 7.0-20 present part K7361, EPC2012.
- Figures 7.0-21 and 7.0-22 present part K7364, EPC2012.
- Figures 7.0-23 and 7.0-24 present part K7365, EPC2012.
- Figures 7.0-25 and 7.0-26 present part K7371, EPC2012.
- Figures 7.0-27 and 7.0-28 present part K7012, EPC1012.

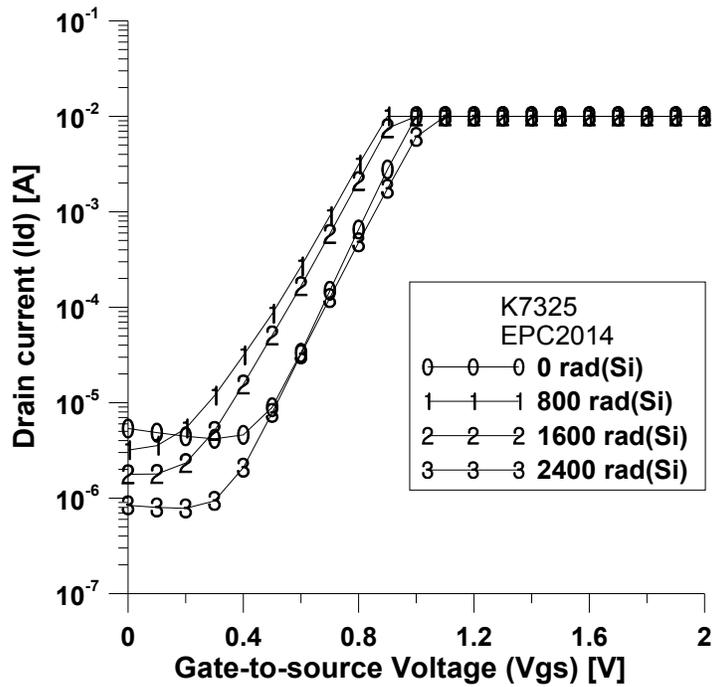
Figure 7.0-2. Effect of heavy ion radiation on the transfer curve K7325. Drain voltage was 10 V. No SEE was seen to $V_{ds}=40$ V and $V_{gs}=-5$ V.

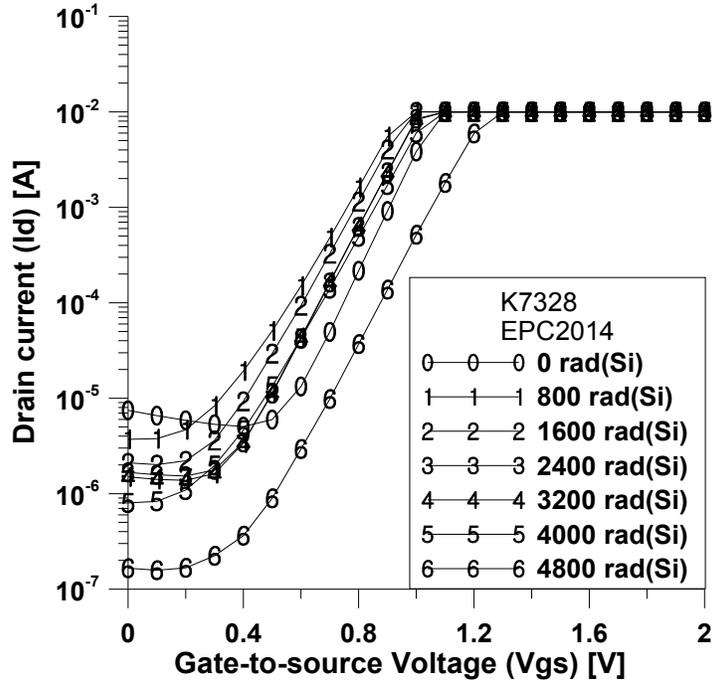
Figure 7.0-3. Effect of heavy ion radiation on the transfer curve K7328. Drain voltage was 10 V. No SEE was seen to $V_{ds}=40$ V and $V_{gs}=-5$ V.

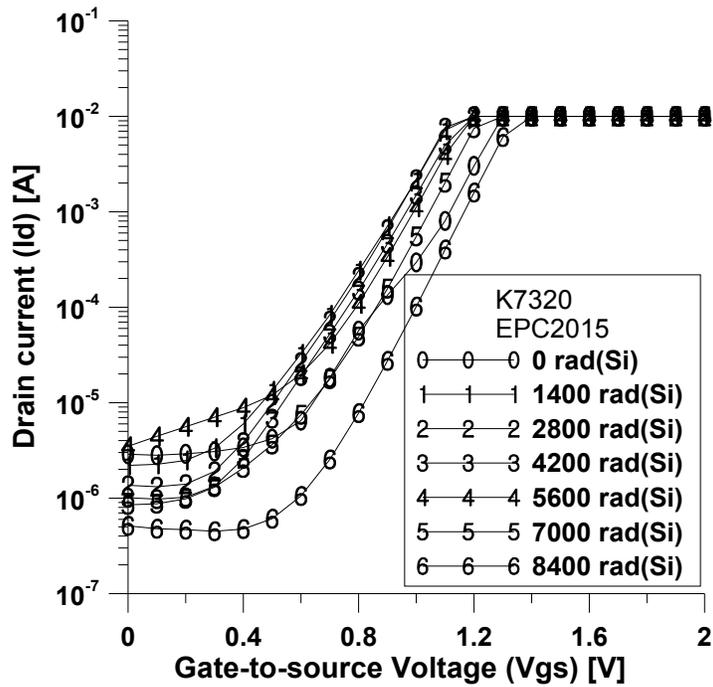
Figure 7.0-4. Effect of heavy ion radiation on the transfer curve K7320. Drain voltage was 10 V. No SEE was seen to $V_{ds}=40$ V and $V_{gs}=-5$ V.

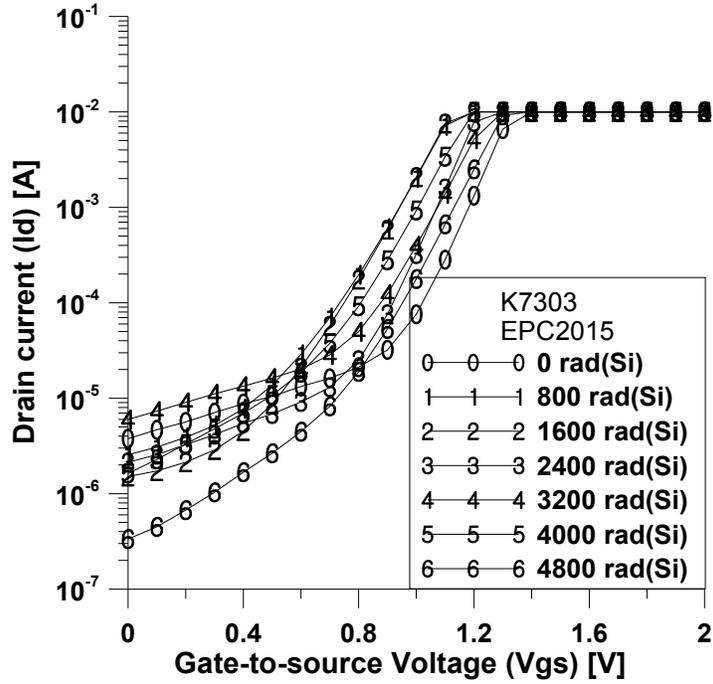
Figure 7.0-5. Effect of heavy ion radiation on the transfer curve K7303. Drain voltage was 10 V. No SEE was seen to $V_{ds}=40$ V and $V_{gs}=-5$ V.

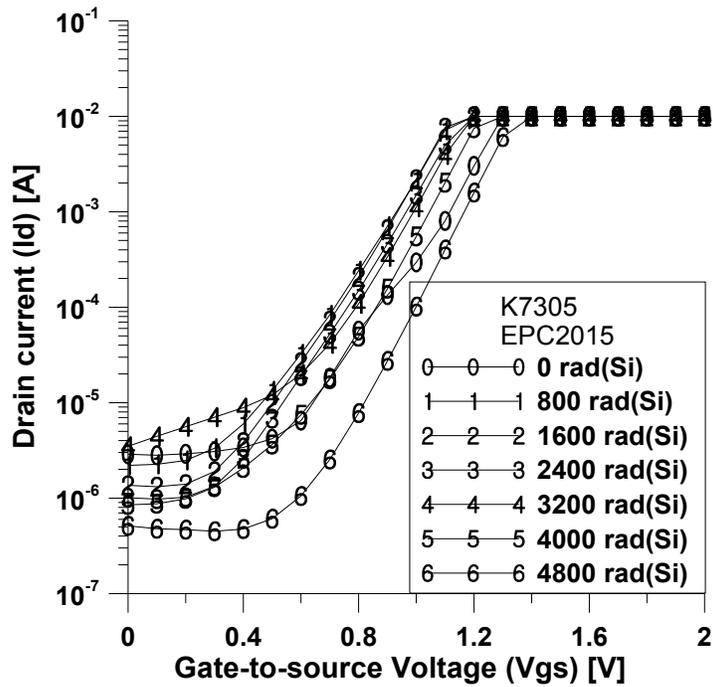
Figure 7.0-6. Effect of heavy ion radiation on the transfer curve K7305. Drain voltage was 10 V. Drain voltage was 10 V. No SEE was seen to $V_{ds}=40$ V and $V_{gs}=-5$ V.

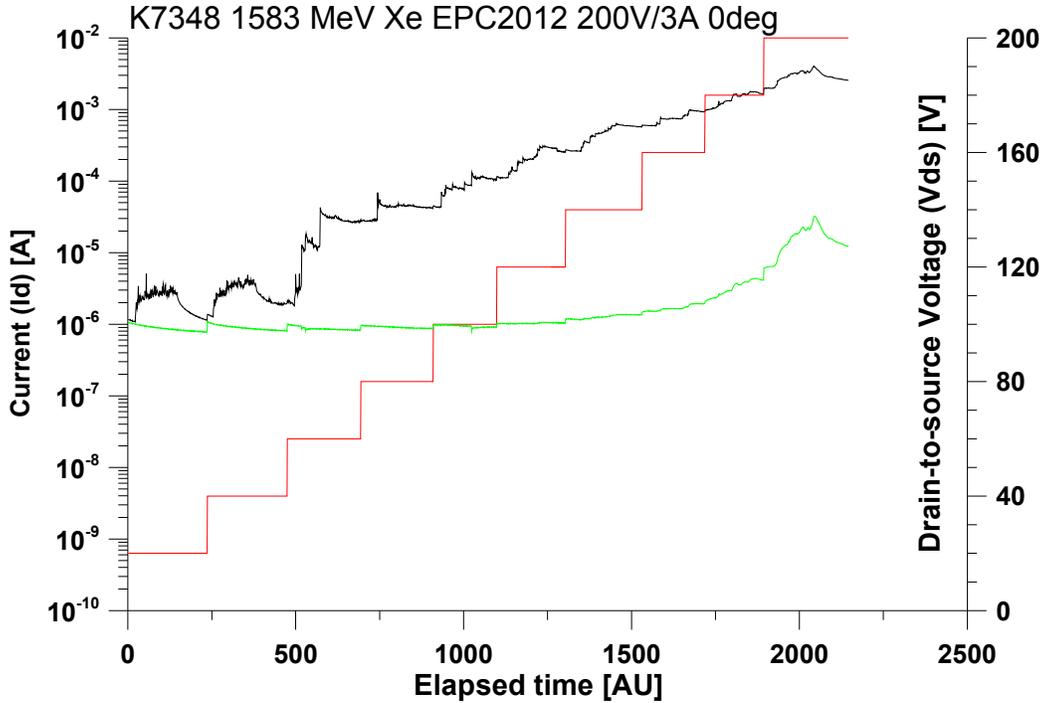
Figure 7.0-7. Heavy ion response of the EPC2012 200 V/3 A. Ion flux was $3E4 \text{ cm}^{-2}\text{-s}^{-1}$. Red line is drain voltage; gate voltage is zero volts. Black line is drain current and green line is gate current. The SEE occurred at $V_{ds}=60 \text{ V}$ and $V_{gs}=0 \text{ V}$.

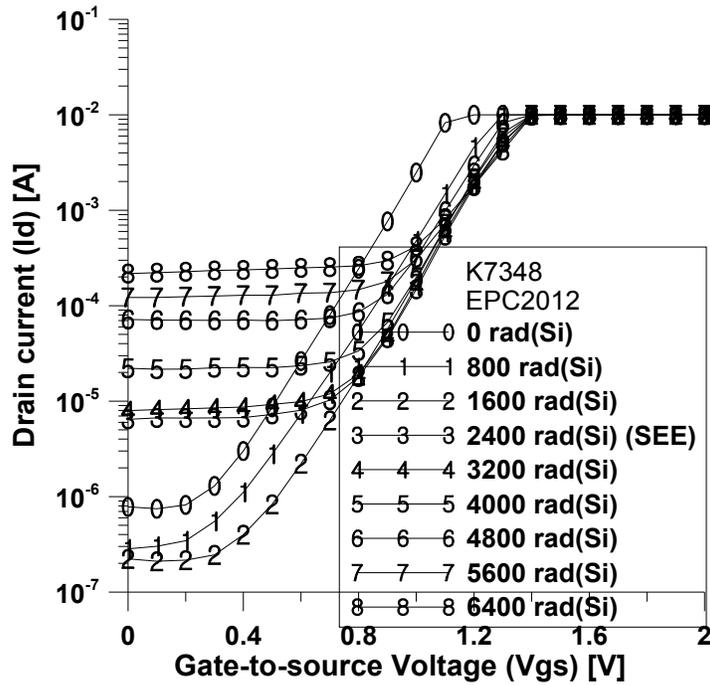
Figure 7.0-8. Effect of heavy ion radiation on the transfer curve K7348. Drain voltage was 10 V. Note the increase in drain leakage after the SEE.

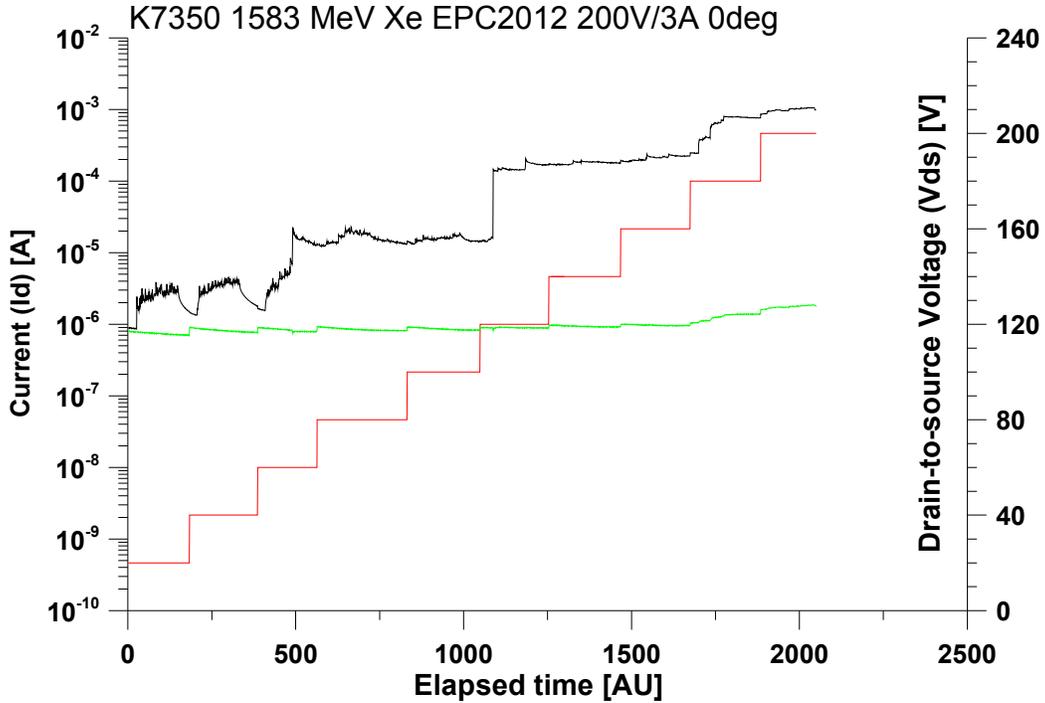
Figure 7.0-9. Heavy ion response of the EPC2012 200 V/3 A. Ion flux was $3E4 \text{ cm}^{-2}\text{s}^{-1}$. Red line is drain voltage; gate voltage is zero volts. Black line is drain current and green line is gate current. The SEE occurred at $V_{ds}=60 \text{ V}$ and $V_{gs}=0 \text{ V}$.

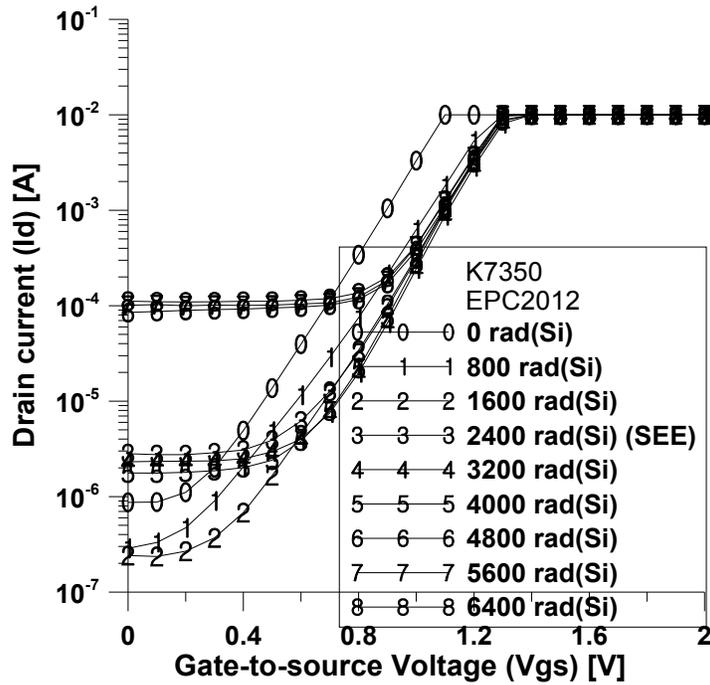
Figure 7.0-10. Effect of heavy ion radiation on the transfer curve K7350. Drain voltage was 10 V. Note the increase in drain leakage after the SEE.

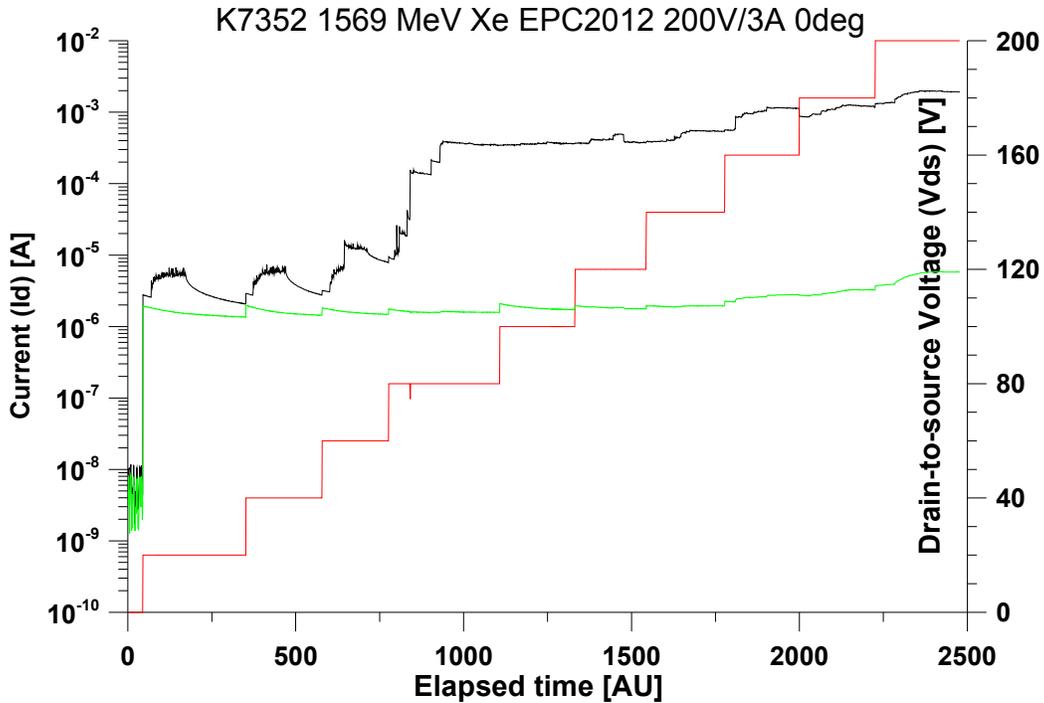
Figure 7.0-11. Heavy ion response of the EPC2012 200 V/3 A. Ion flux was $3E4 \text{ cm}^{-2}\text{-s}^{-1}$. Red line is drain voltage; gate voltage is zero volts. Black line is drain current and green line is gate current. The SEE occurred at $V_{ds}=60 \text{ V}$ and $V_{gs}=0 \text{ V}$.

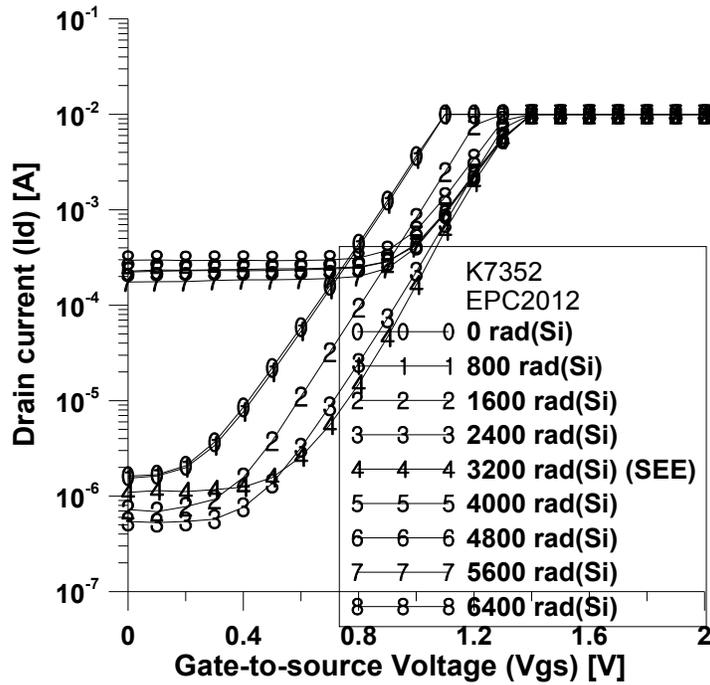
Figure 7.0-12. Effect of heavy ion radiation on the transfer curve K7352. Drain voltage was 10 V. Note the increase in drain leakage after the SEE.

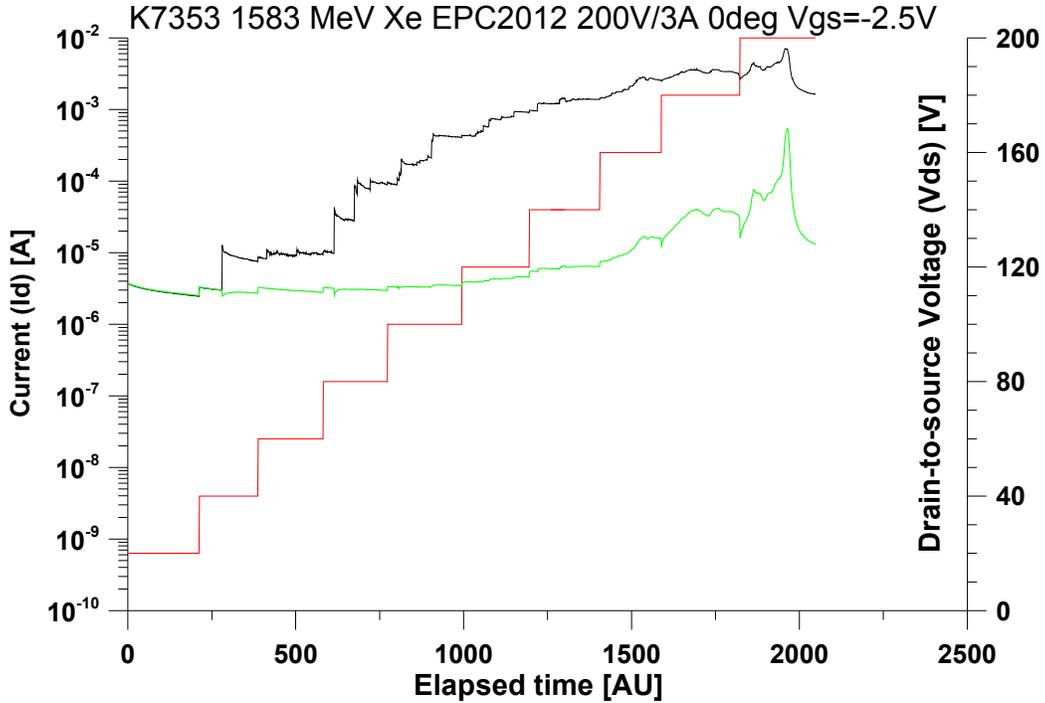
Figure 7.0-13. Heavy ion response of the EPC2012 200V/3A 0deg. Ion flux was $3E4 \text{ cm}^{-2}\text{s}^{-1}$. Red line is drain voltage; gate voltage is zero volts. Black line is drain current and green line is gate current. The SEE occurred at $V_{ds}=40 \text{ V}$ and $V_{gs}=0 \text{ V}$.

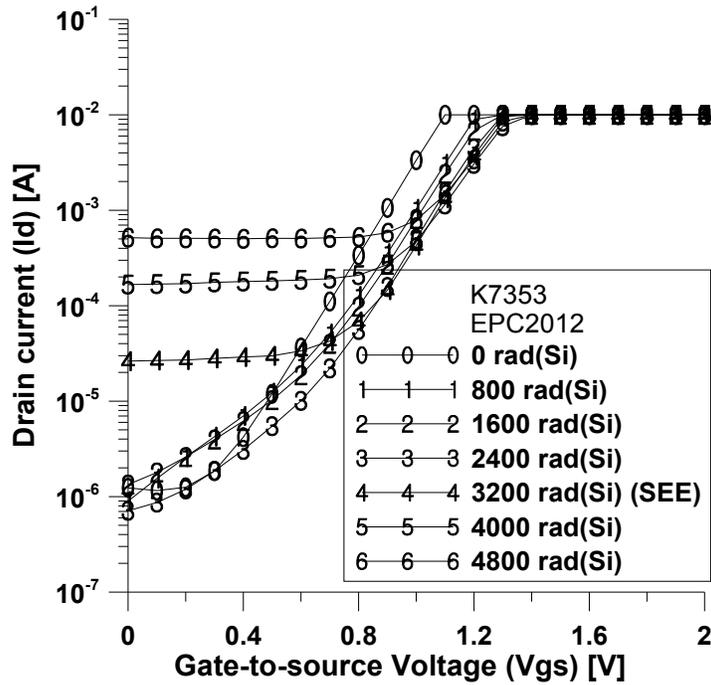
Figure 7.0-14. Effect of heavy ion radiation on the transfer curve K7353. Drain voltage was 10 V.

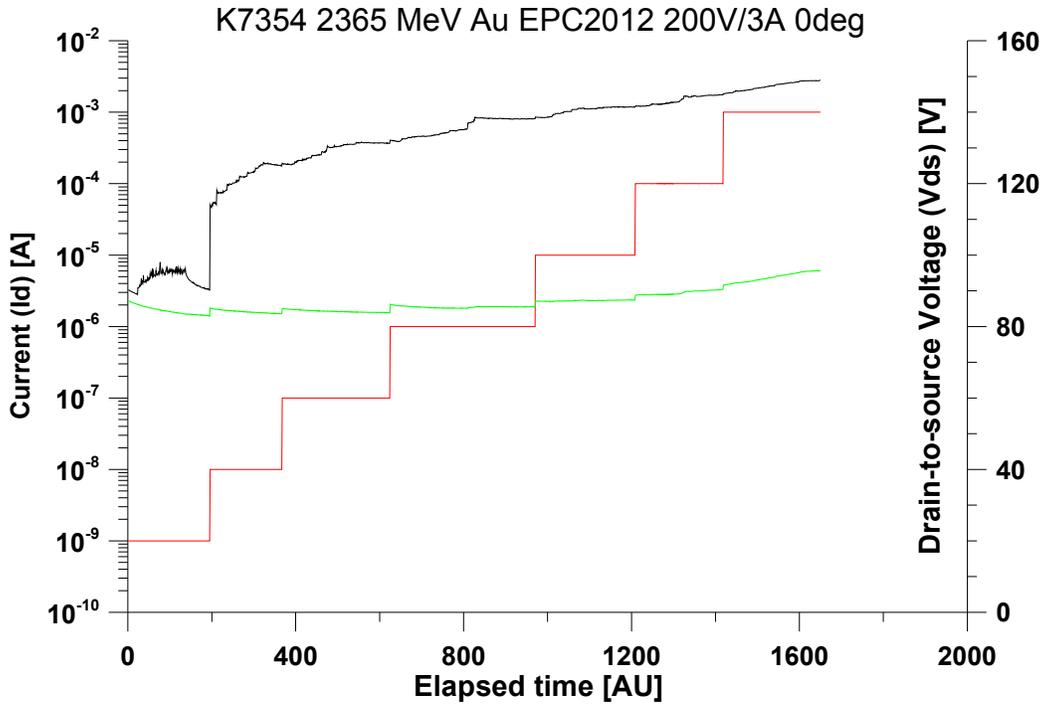
Figure 7.0-15. Heavy ion response of the EPC2012 200 V/3 A. Ion flux was $3E4 \text{ cm}^{-2}\text{-s}^{-1}$. Red line is drain voltage; gate voltage is zero volts. Black line is drain current and green line is gate current.

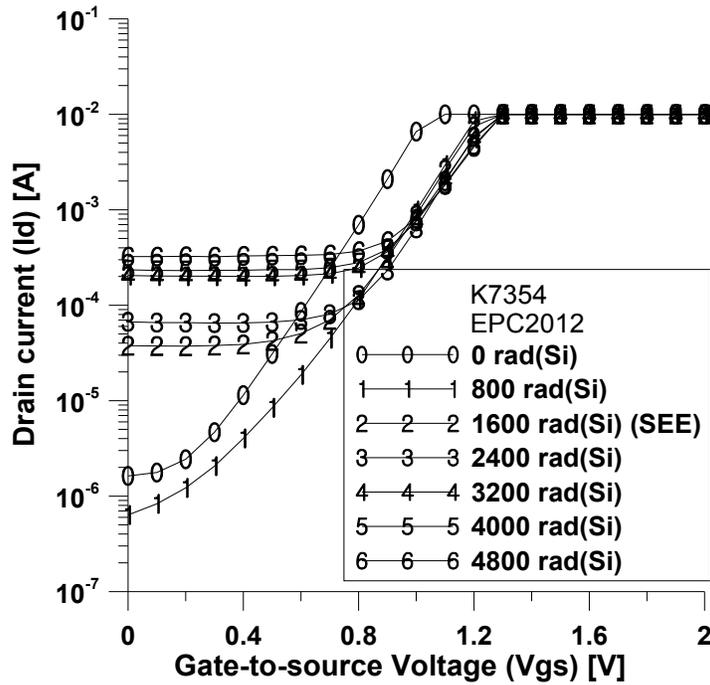
Figure 7.0-16. Effect of heavy ion radiation on the transfer curve K7354. Drain voltage was 10 V.

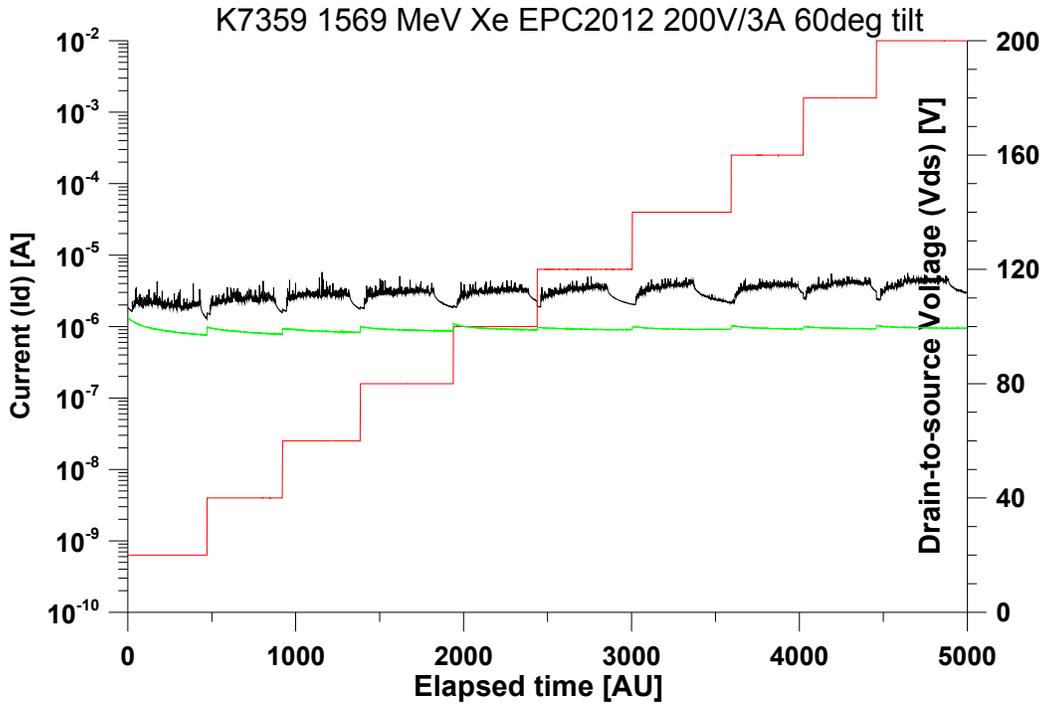
Figure 7.0-17. Heavy ion response of the EPC2012 200 V/3 A 60 deg. Ion flux was $3E4 \text{ cm}^{-2}\text{s}^{-1}$. Red line is drain voltage; gate voltage is zero volts. Black line is drain current and green line is gate current.

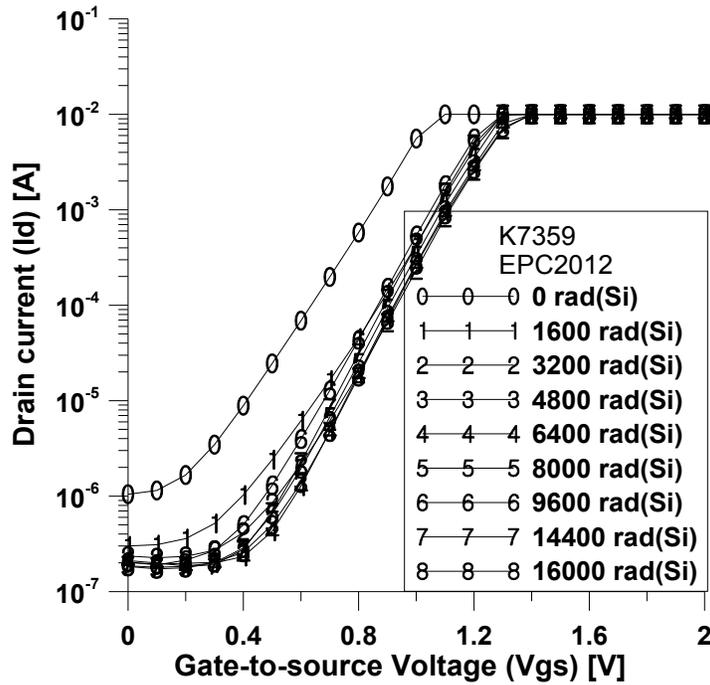
Figure 7.0-18. Effect of heavy ion radiation on the transfer curve K7359. Drain voltage was 10 V.

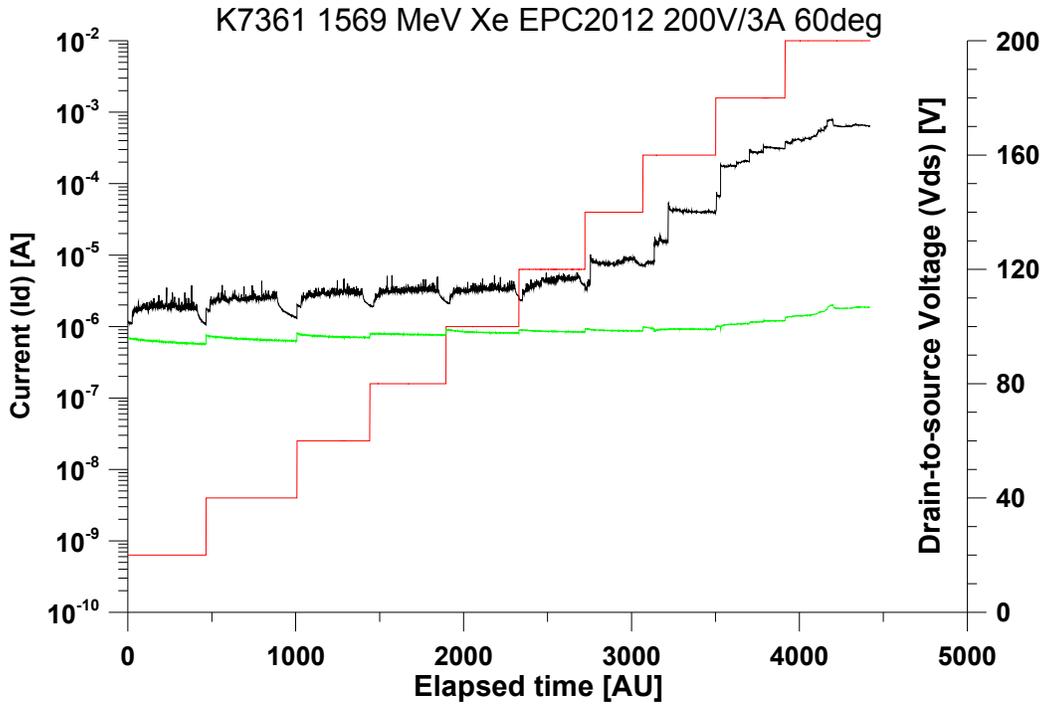
Figure 7.0-19. Heavy ion response of the EPC2012 200 V/3 A 60 deg. Ion flux was $3E4 \text{ cm}^{-2}\text{s}^{-1}$. Red line is drain voltage; gate voltage is zero volts. Black line is drain current and green line is gate current.

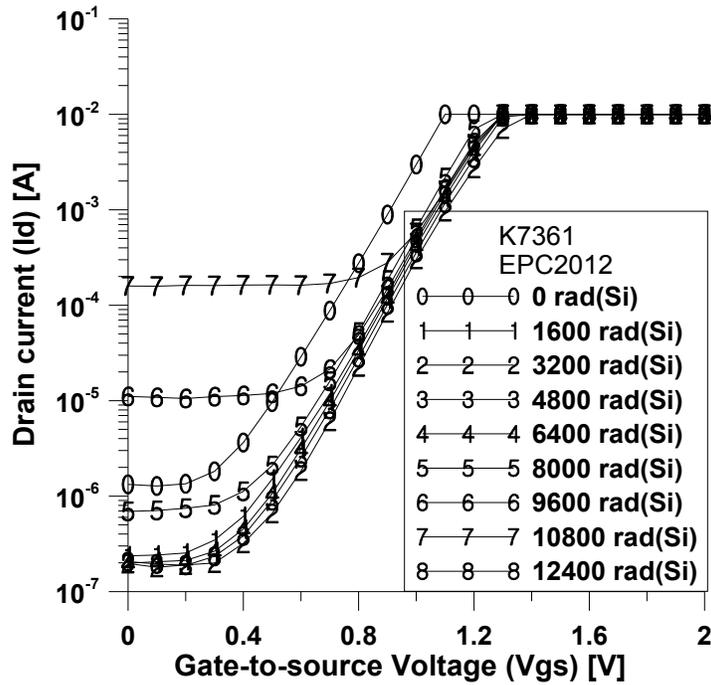
Figure 7.0-20. Effect of heavy ion radiation on the transfer curve K7361. Drain voltage was 10 V.

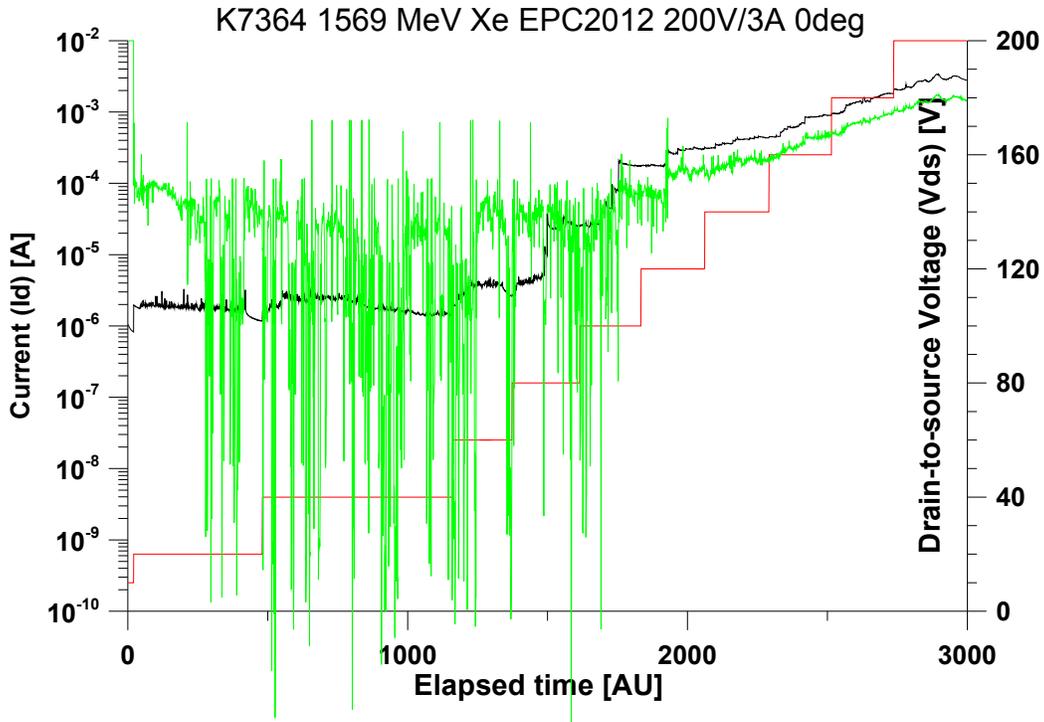
Figure 7.0-21. Heavy ion response of the EPC2012 100 V/25 A 0 deg. Ion flux was $3E4 \text{ cm}^{-2}\text{s}^{-1}$. Red line is drain voltage; gate voltage is zero volts. Black line is drain current and green line is gate current. Current noise occurs in some devices when near the voltage threshold.

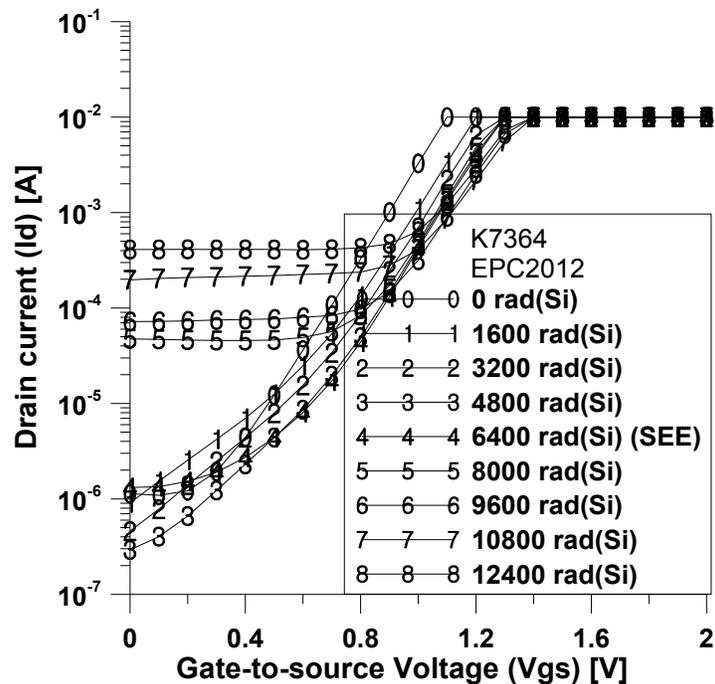
Figure 7.0-22. Effect of heavy ion radiation on the transfer curve K7364. Drain voltage was 10 V.

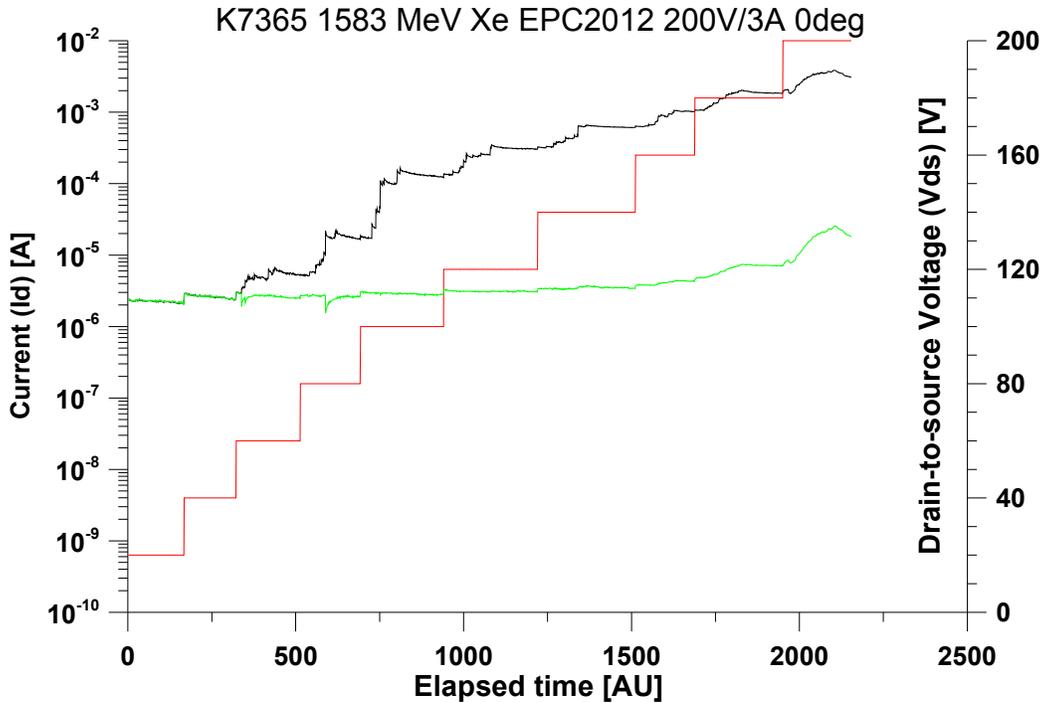
Figure 7.0-23. Heavy ion response of the EPC2012 100 V/25 A 0 deg. Ion flux was $3E4 \text{ cm}^{-2}\text{s}^{-1}$. Red line is drain voltage; gate voltage is zero volts. Black line is drain current and green line is gate current. Drain-to-source voltage = -2.5 V .

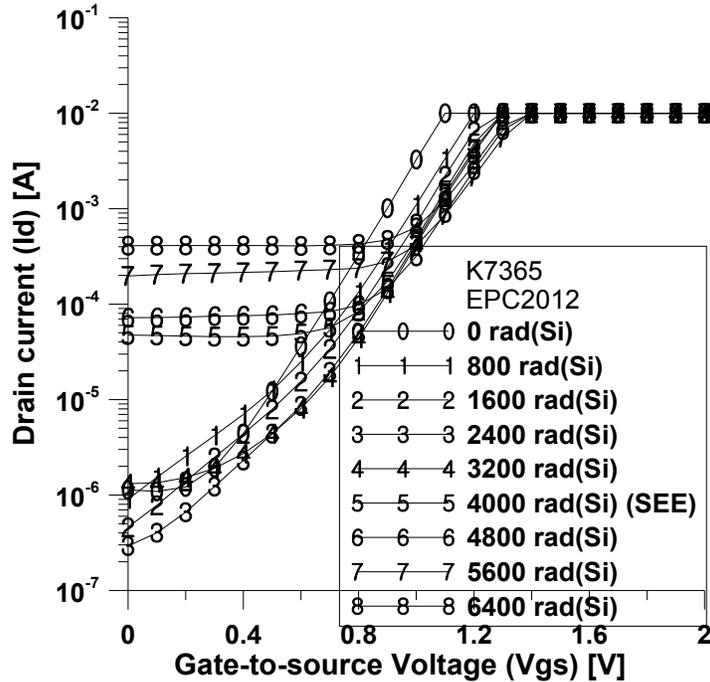
Figure 7.0-24. Effect of heavy ion radiation on the transfer curve K7365. Drain voltage was 10 V .

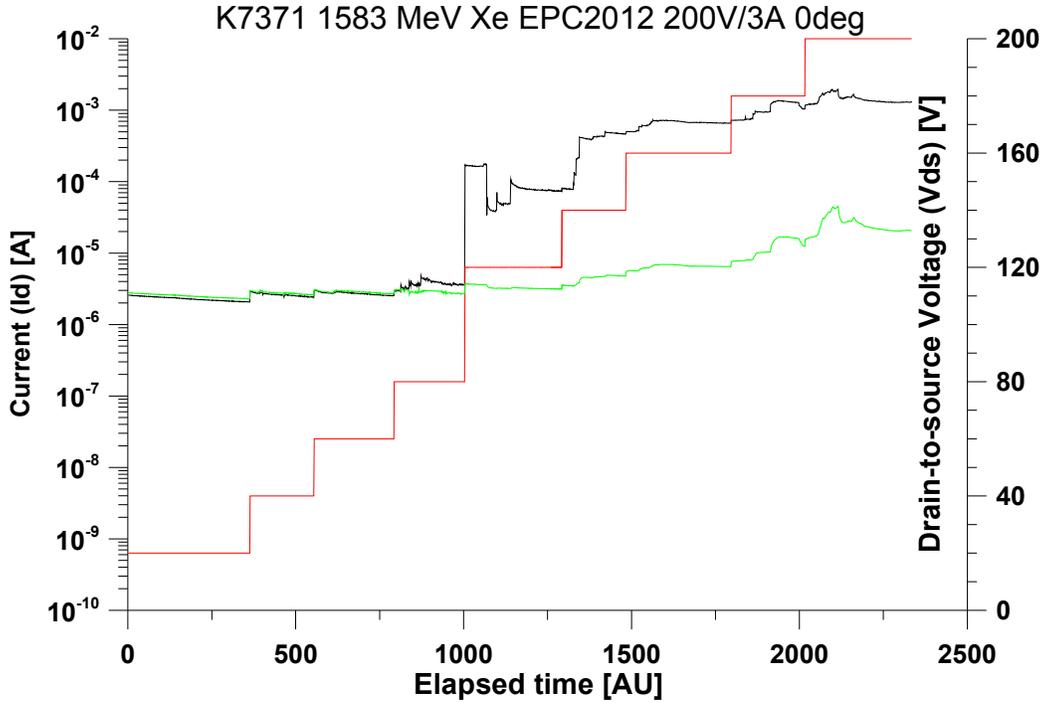
Figure 7.0-25. Heavy ion response of the EPC2012 100 V/25 A 0 deg. Ion flux was $3E4 \text{ cm}^{-2}\text{s}^{-1}$. Red line is drain voltage; gate voltage is zero volts. Black line is drain current and green line is gate current. Drain-to-source voltage = -2.5 V .

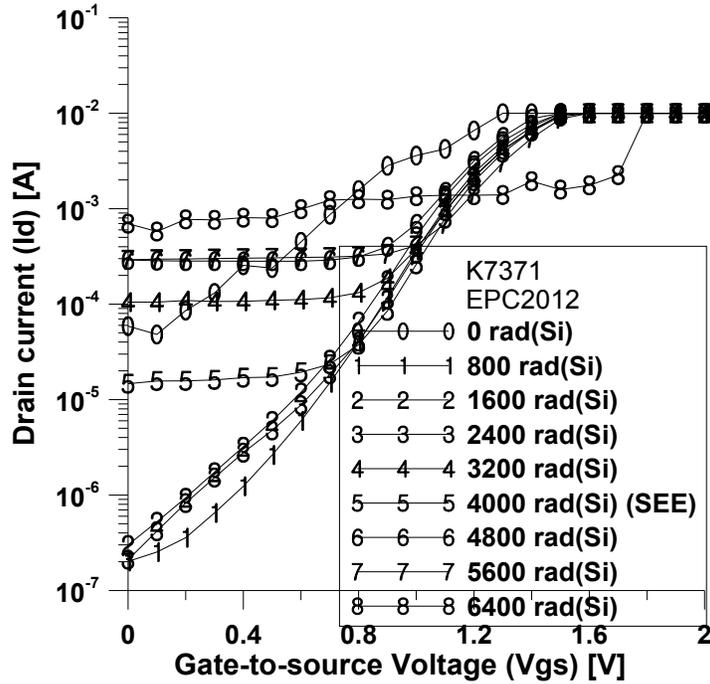
Figure 7.0-26. Effect of heavy ion radiation on the transfer curve K7371. Drain voltage was 10 V .

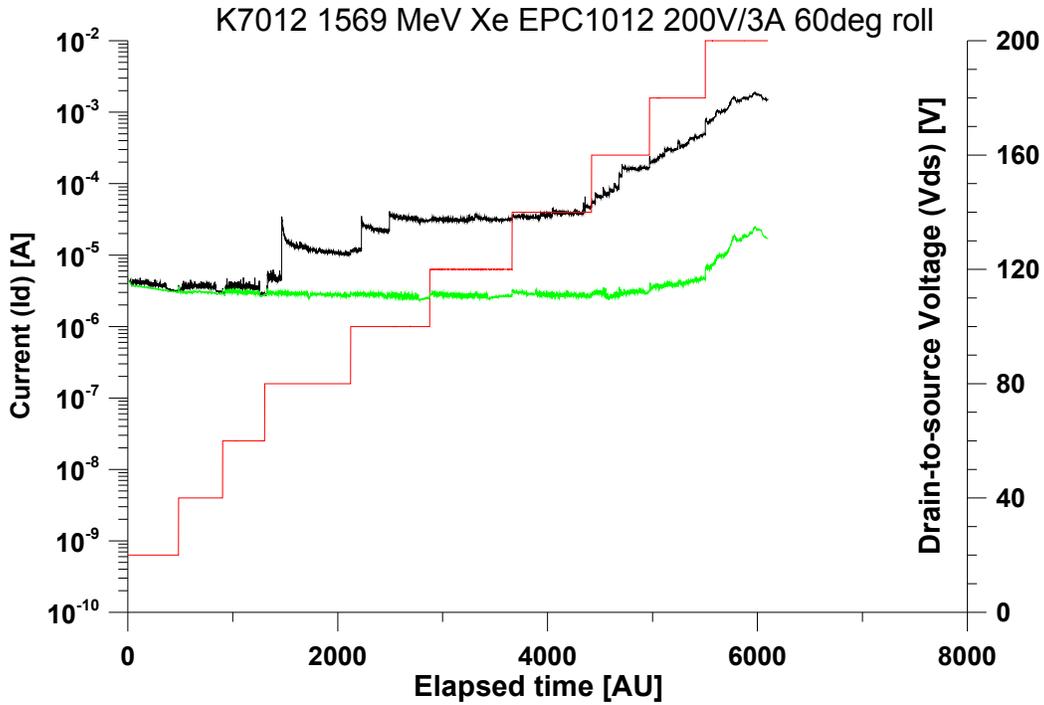
Figure 7.0-27. Heavy ion response of the EPC1012 100 V/25 A 60 deg. Ion flux was $3E4 \text{ cm}^{-2}\text{s}^{-1}$. Red line is drain voltage; gate voltage is zero volts. Black line is drain current and green line is gate current .

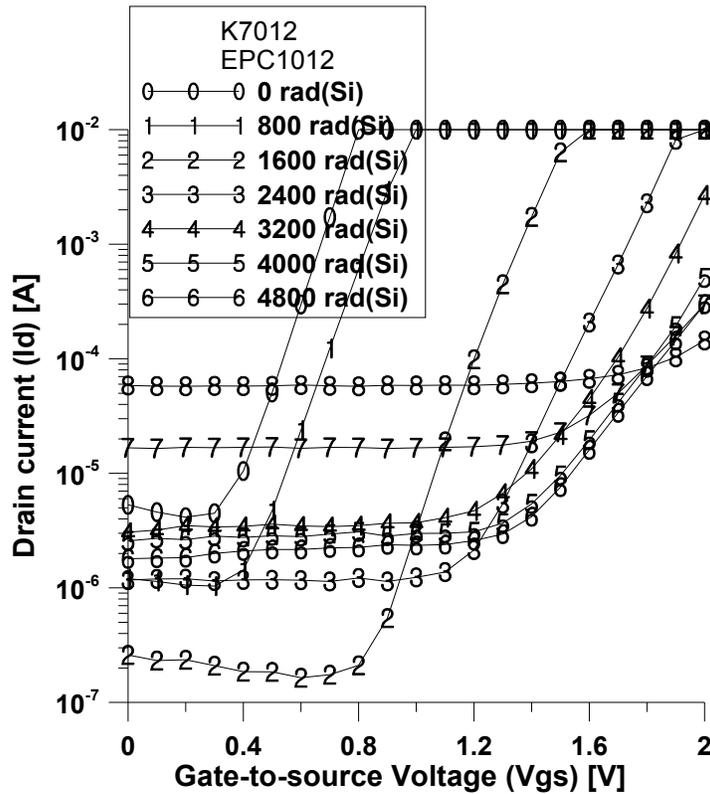
Figure 7.0-28. Effect of heavy ion radiation on the transfer curve K7012. Drain voltage was 10 V.
